MATERIALS FOR POTASSIUM LUBRICATED JOURNAL BEARINGS

Quarterly Progress Report No. 9
Quarter Ending July 22, 1965

prepared for
NATIONAL AERONAUTICS AND SPACE ADMINISTRATION
CONTRACT NAS 3-2534

SPACE POWER AND PROPULSION SECTION
MISSILE AND SPACE DIVISION
GENERAL   ELECTRIC
CINCINNATI, OHIO 45215

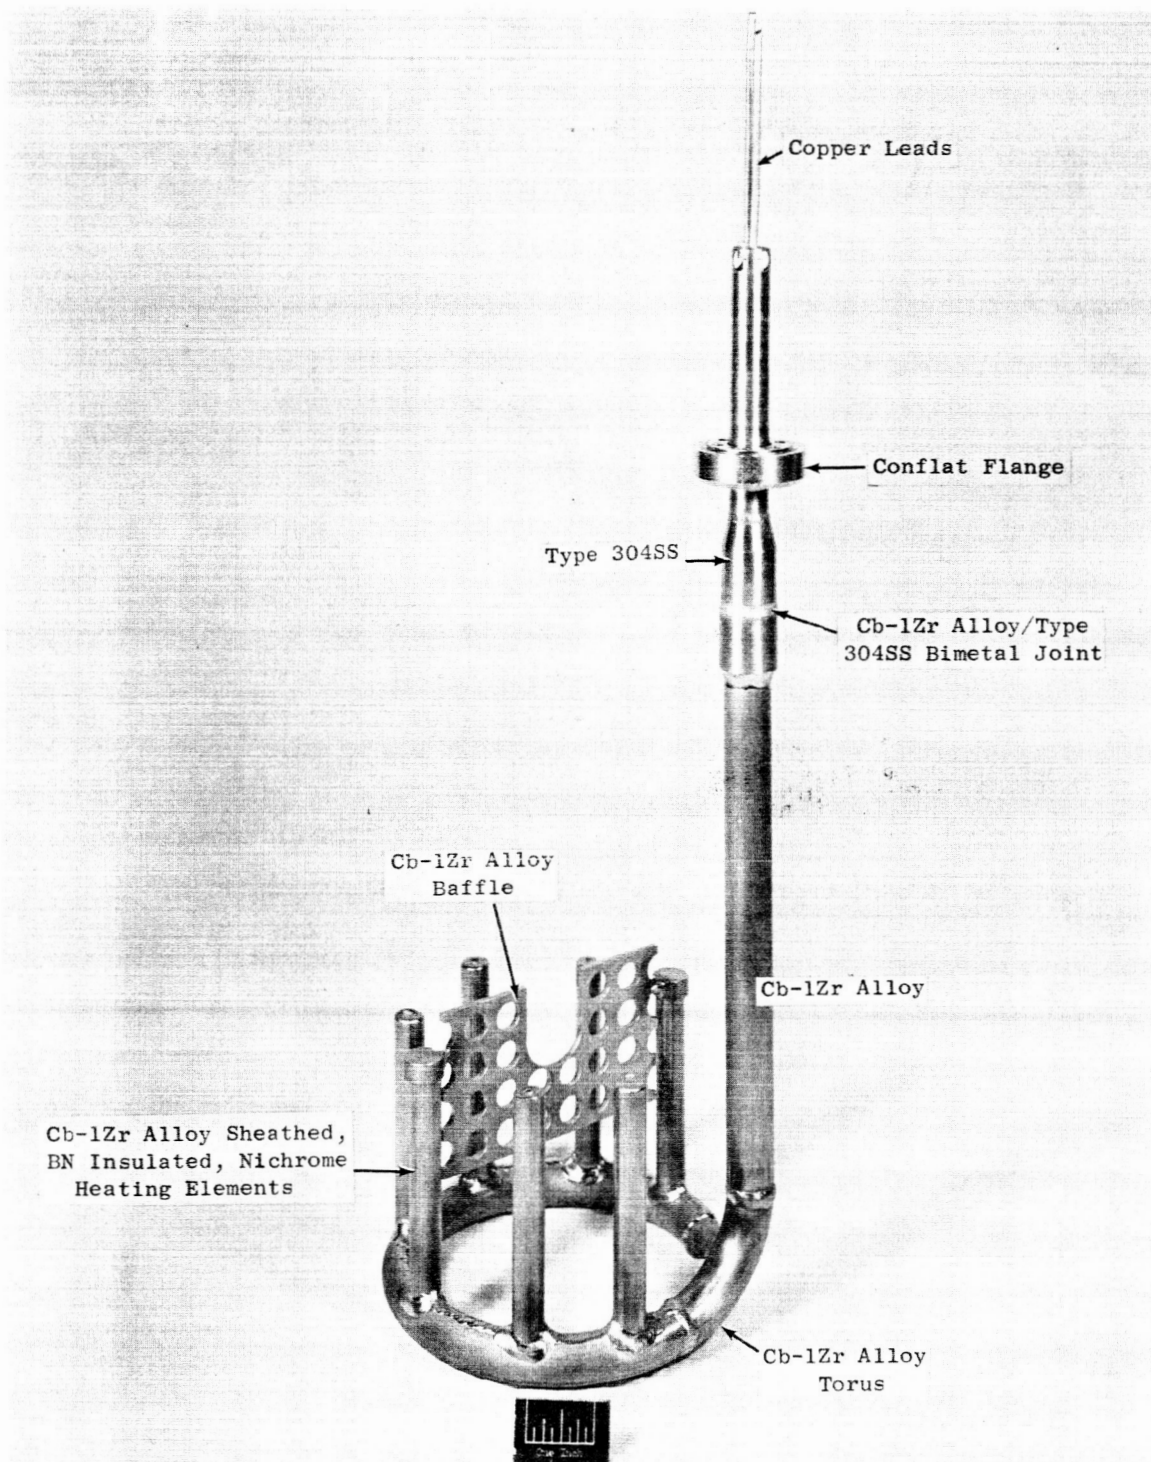
Figure 1. Conductive Immersion Heater Assembly for Potassium Friction and Wear Tester.

The Cb-1Zr alloy sheathed, BN insulated conductive immersion heater assembly was fabricated successfully and tests for leaks and electrical continuity indicated the heater assembly to be suitable for installation in the test rig. Compatibility tests of Cb-1Zr alloy sheathed, Al_2O_3 insulated heater were conducted in vacuum (10^{-9} torr) for 118 hours at 1600°F . The breakdown voltage of the Al_2O_3 (99.5% Al_2O_3) insulated heater was found to be 100 volts after the 118-hour exposure. Similar tests for the BN (99.5%BN) insulated heater indicated breakdown voltages in excess of 3000 volts. All heaters successfully withstood an applied potential of 2100 volts between the Nichrome elements and the Cb-1Zr alloy sheath prior to conducting the 118-hour compatibility test.

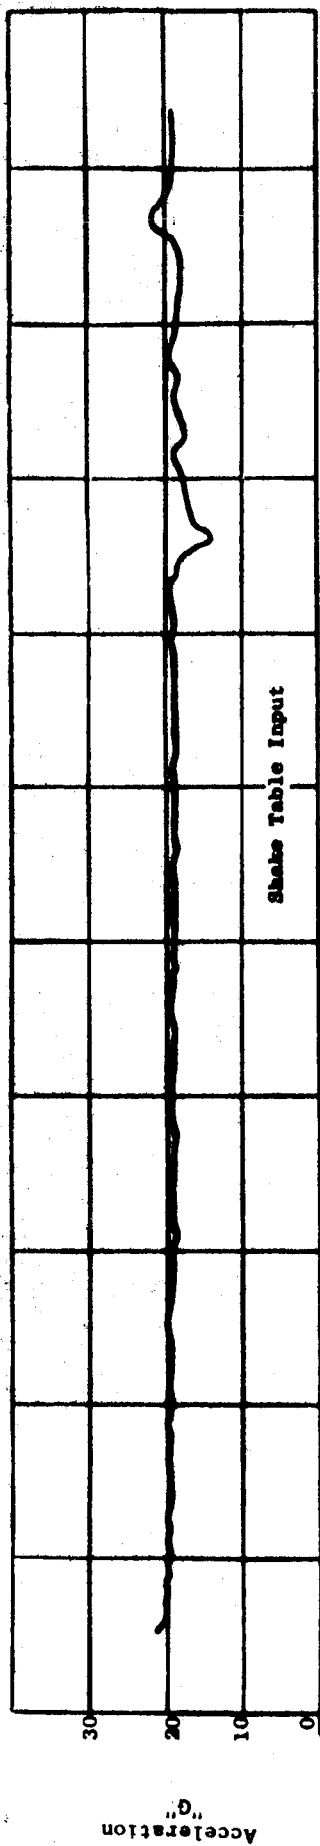
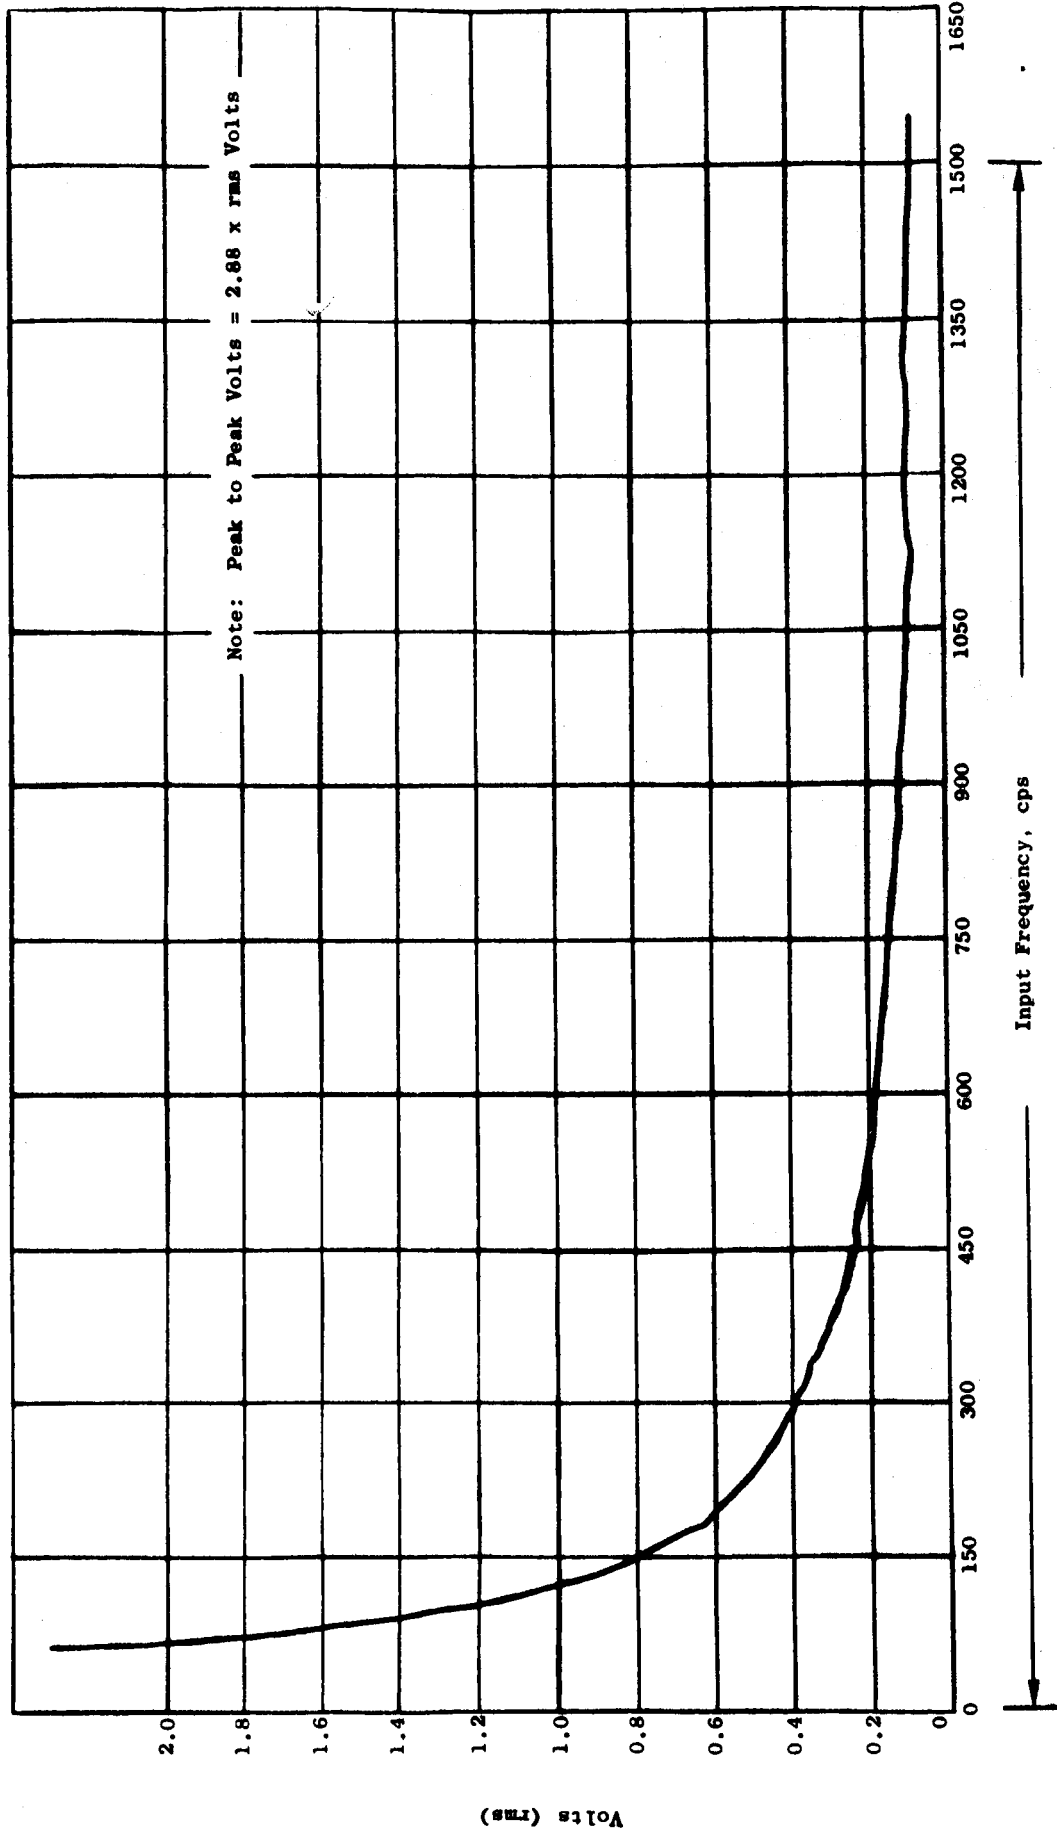
Figure 2. Calibration Curve for Vibration Pickup No. 2898.

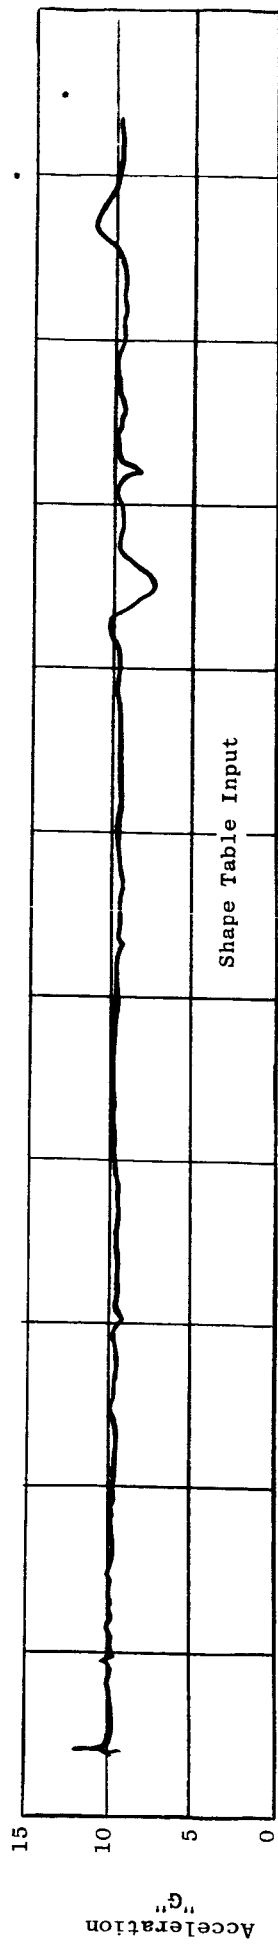
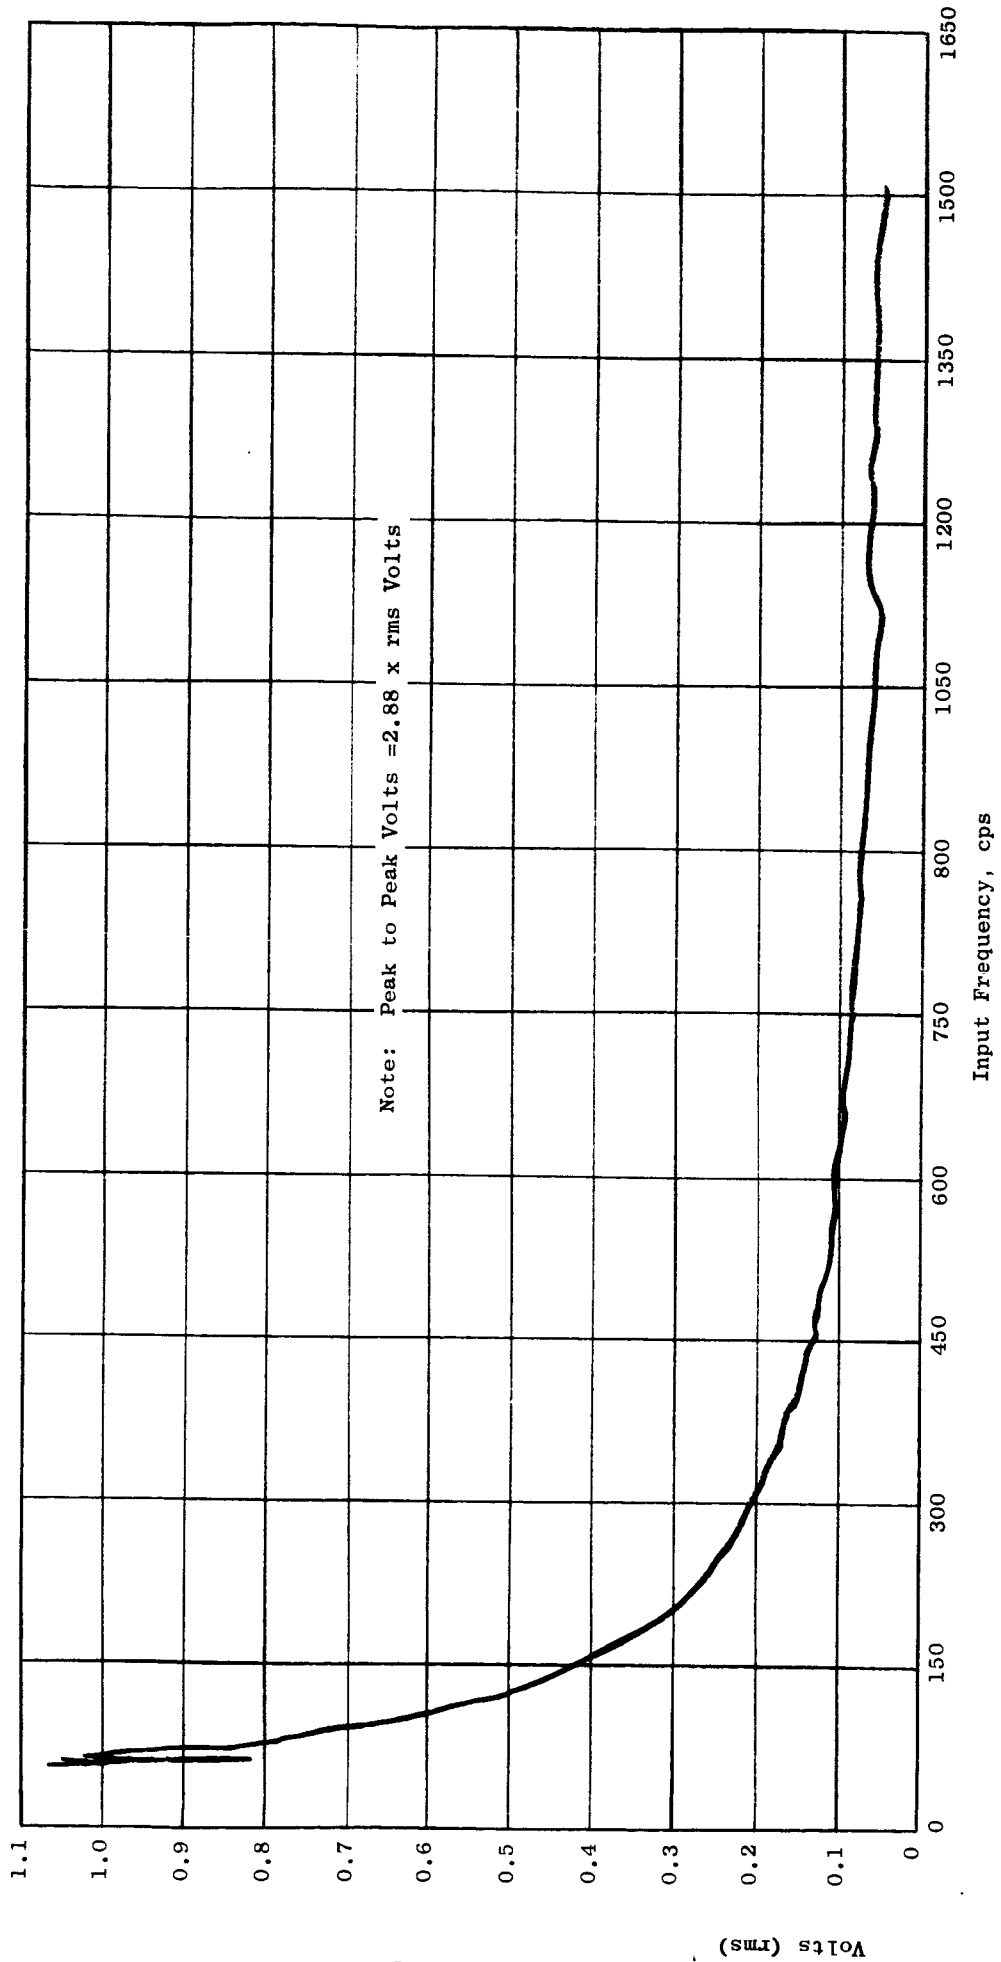
Figure 3. Calibration Curve for Vibration Pickup No. 5019.

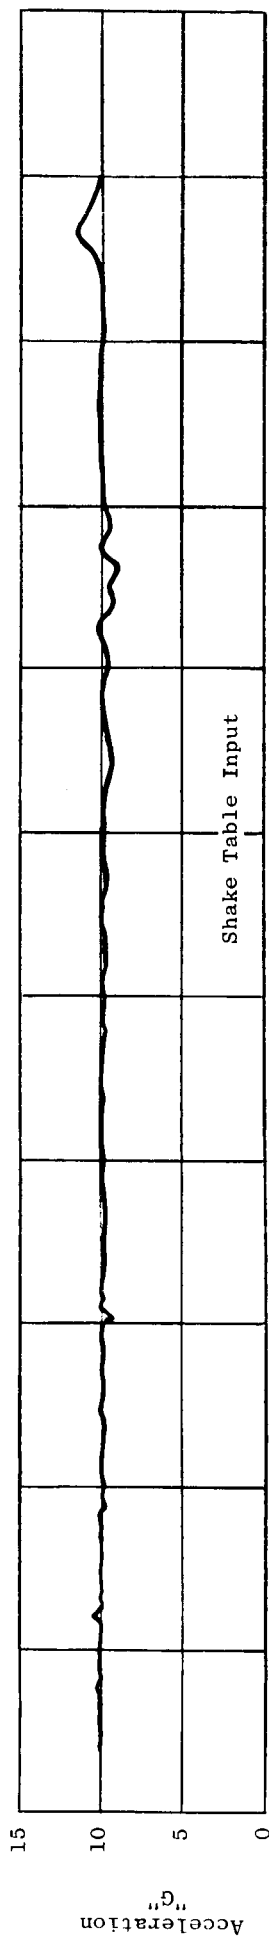
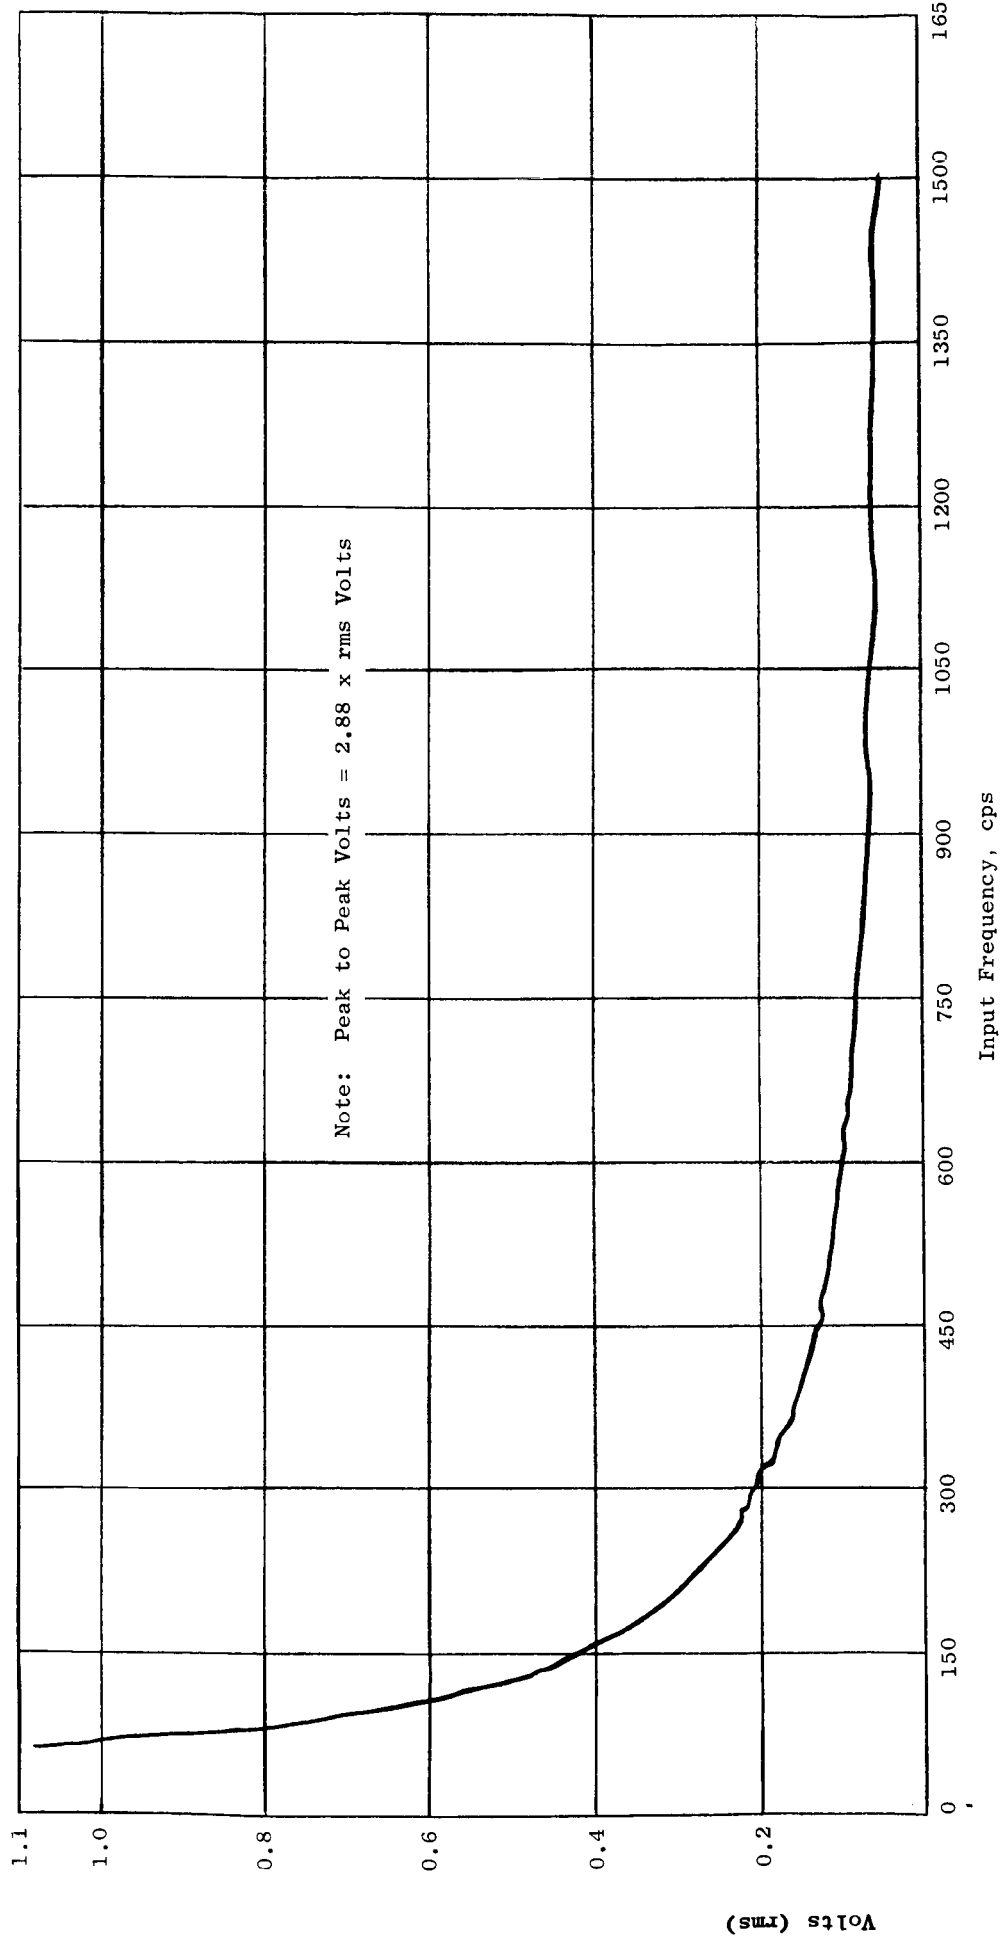
Figure 4. Calibration Curve for Vibration Pickup No. 4772.

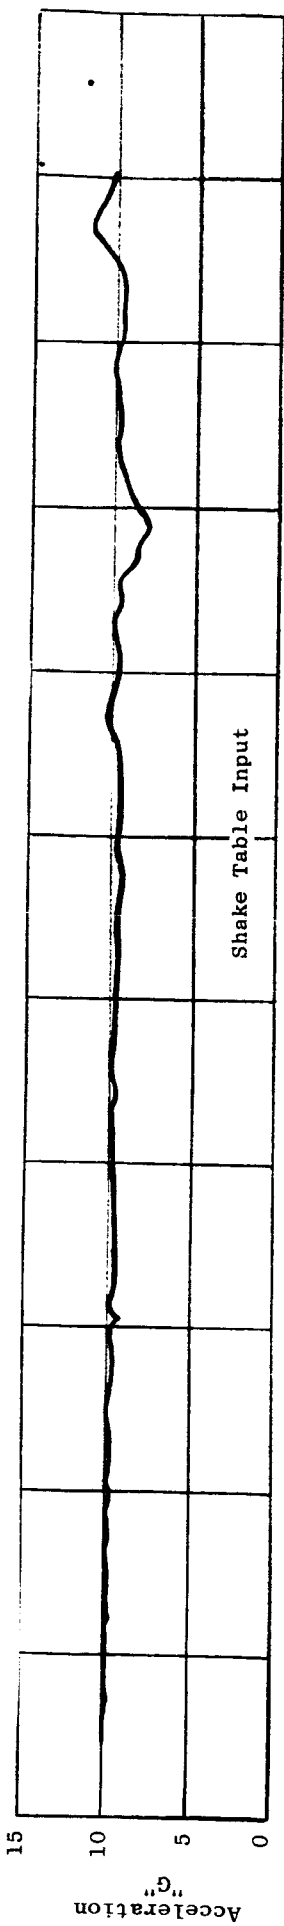
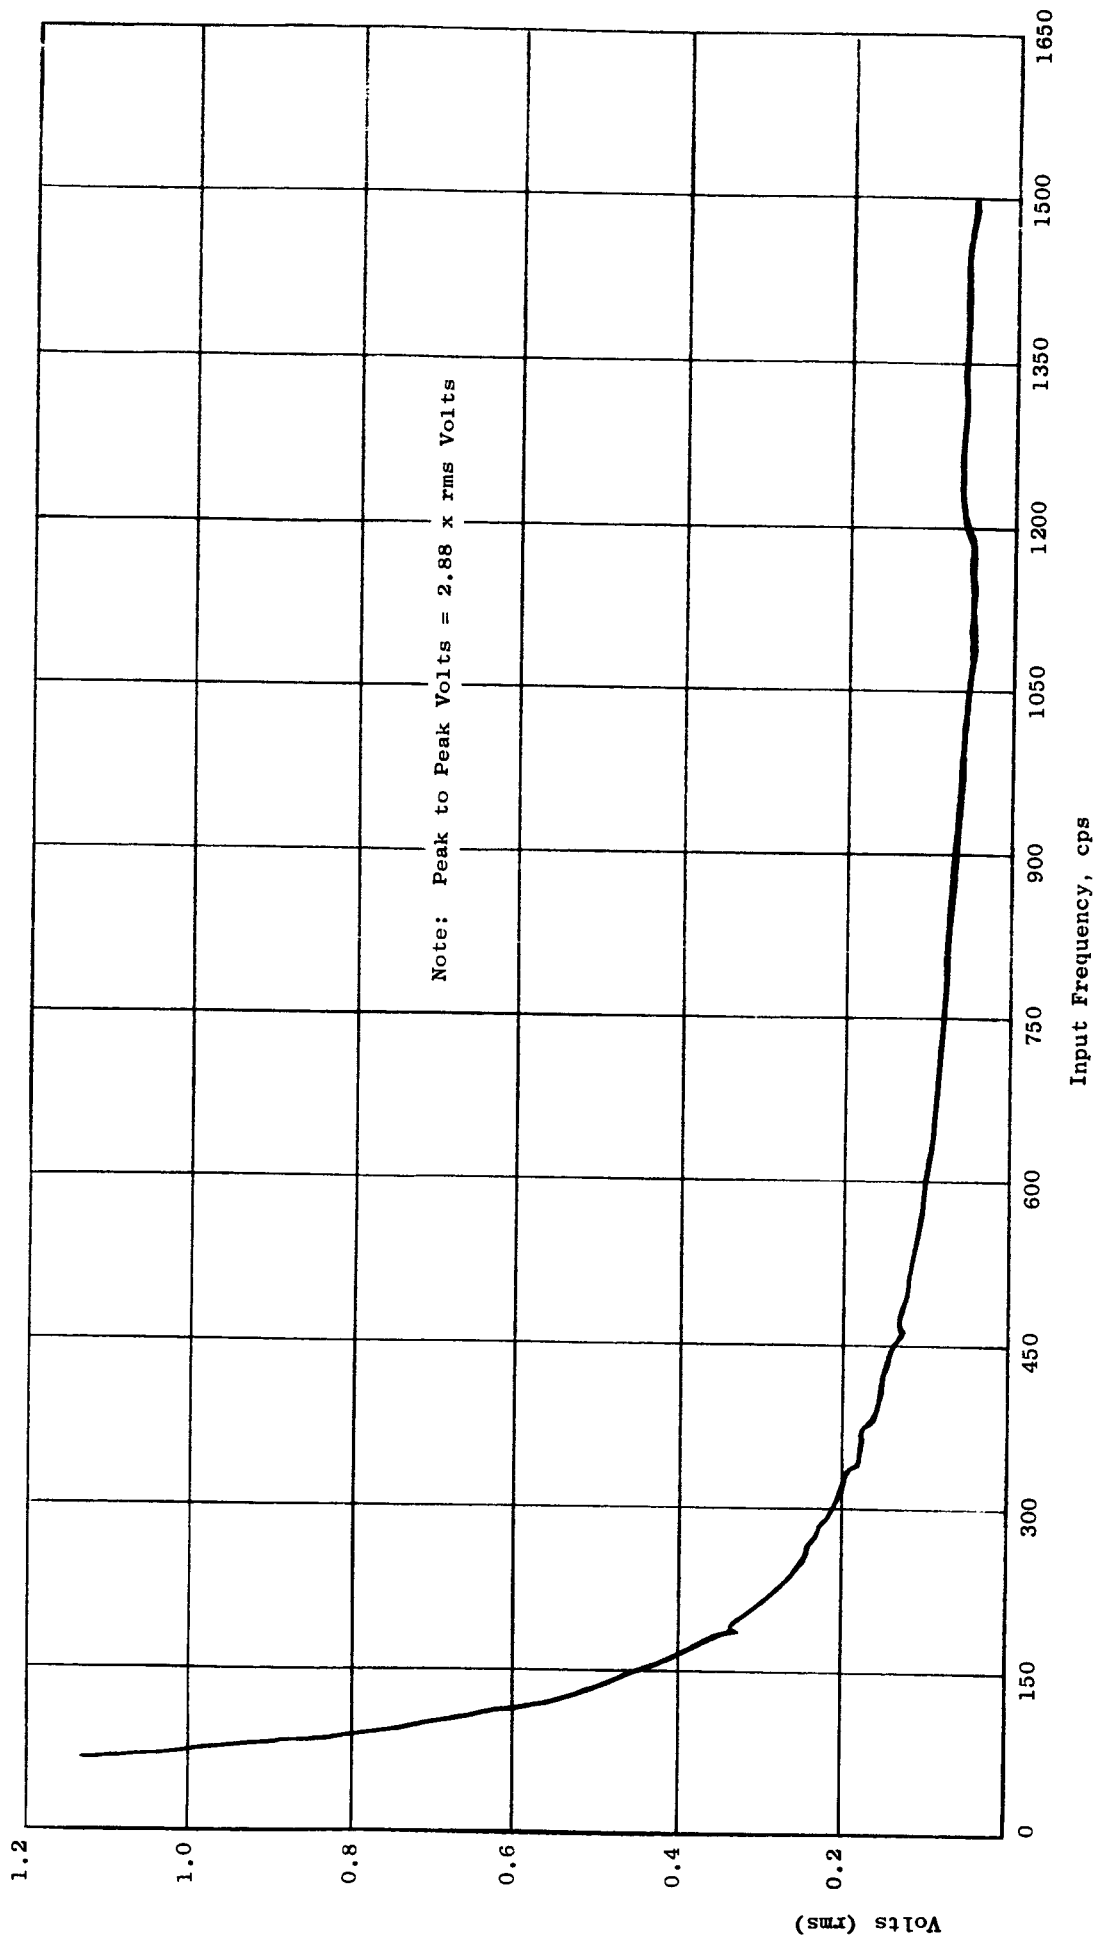
Figure 5. Calibration Curve for Vibration Pickup No. 4769.

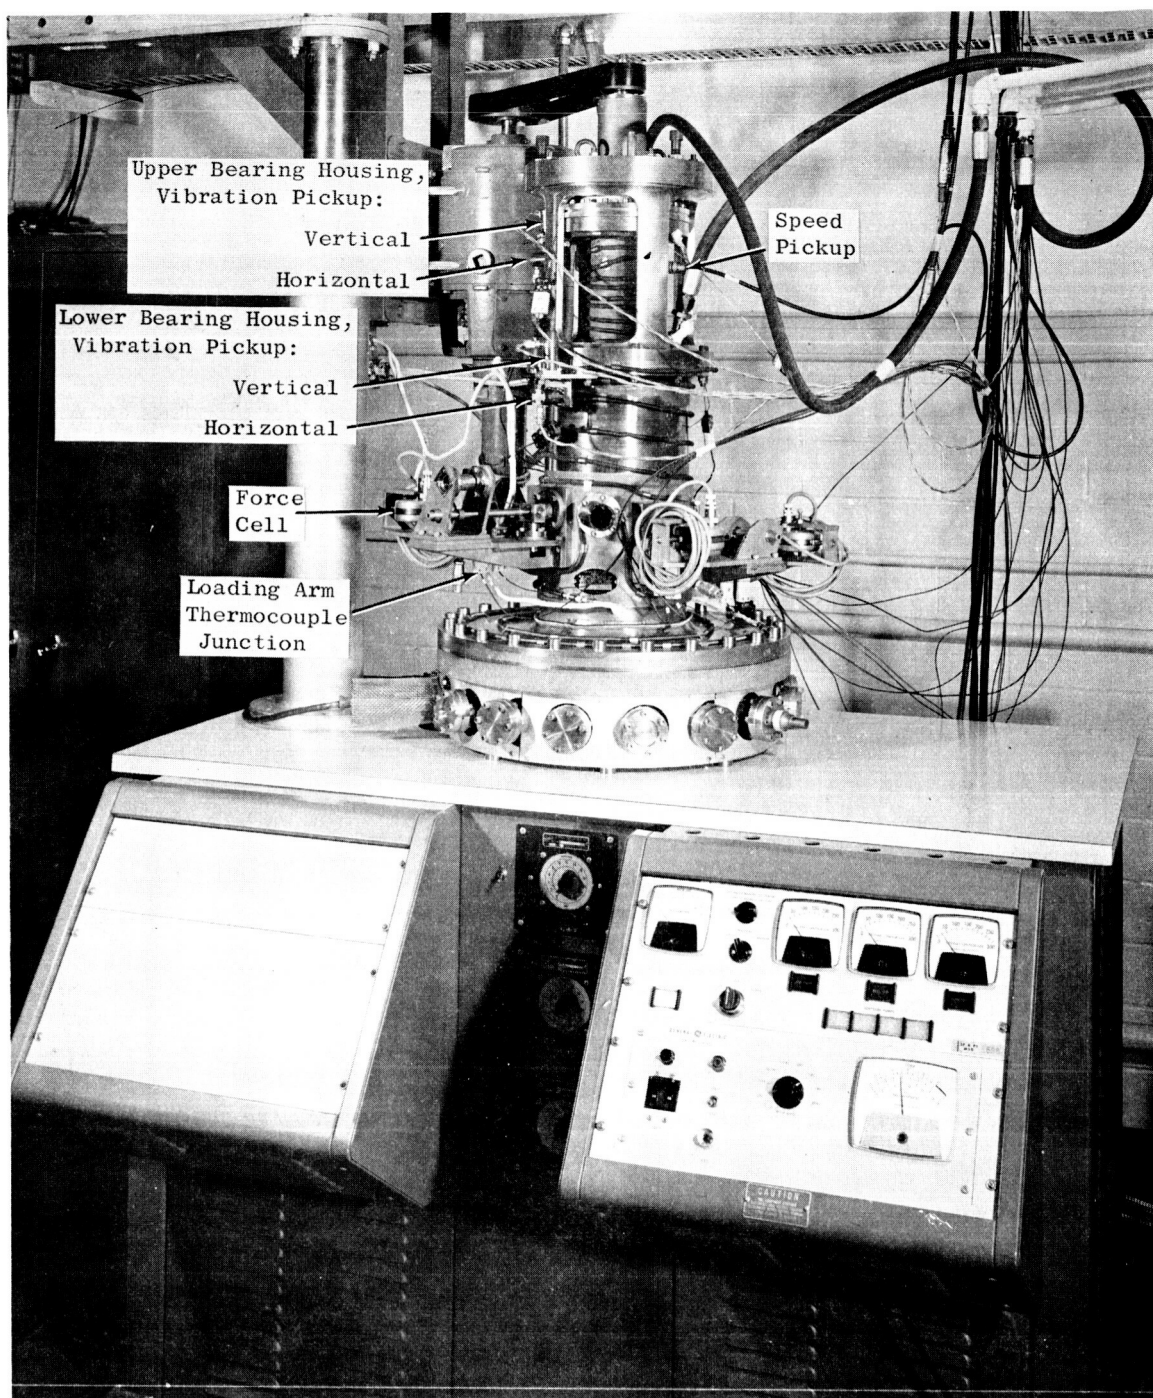
Figure 6. High Vacuum Friction Tester Fully Instrumented Prior to Test.

The HVFT was assembled as shown in Figure 6. No hemispherical rider specimens were installed in the loading arms and no cooling coils were installed inside the vacuum chamber. Otherwise, the tester was assembled as it would be during actual testing. The four Mo-TZM alloy disc specimens were included in this assembly to prevent their holding screws, nuts, and washers from moving and affecting the balance of the shaft assembly during the rotational tests. Also, their presence also duplicated the heat transfer conditions of actual testing.

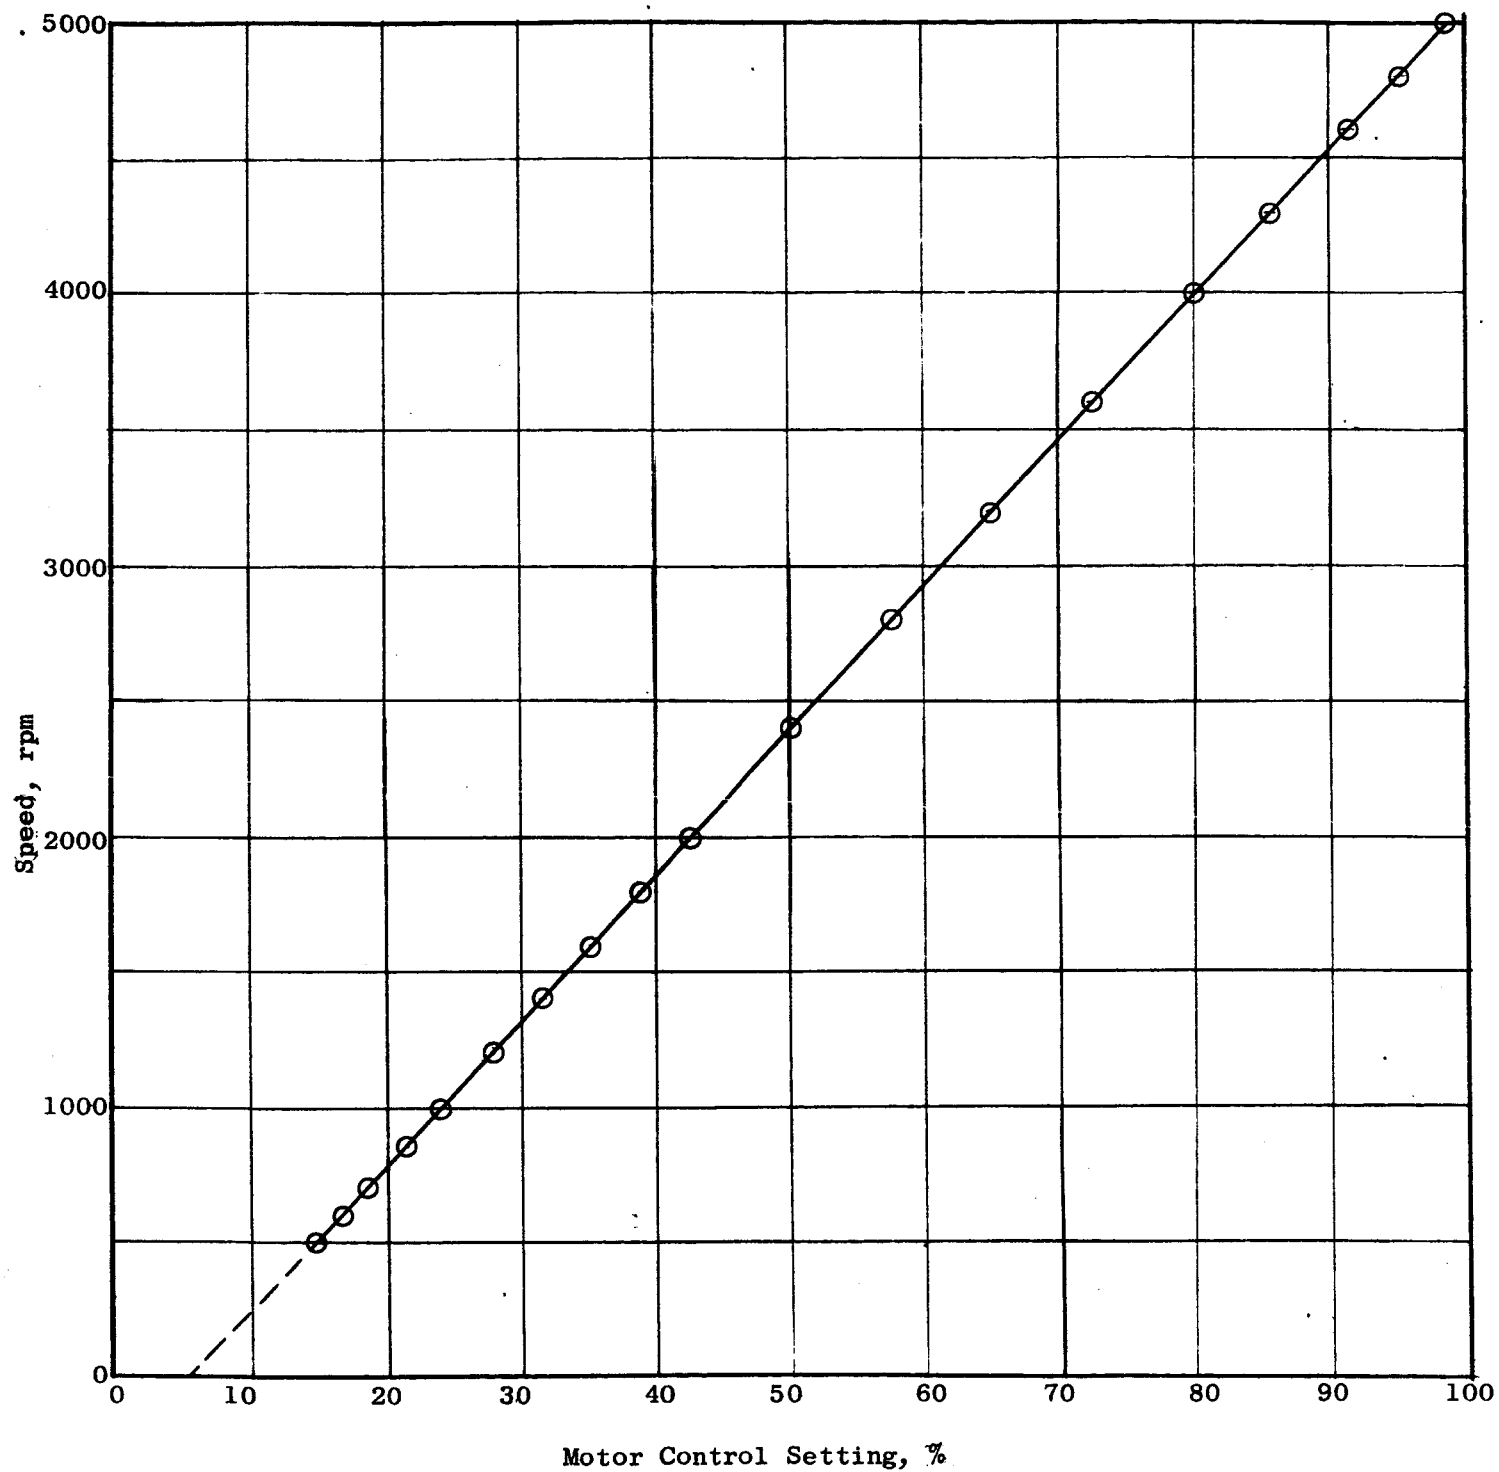
Figure 7. Speed Calibration of Electric Drive Motor Control Setting.

1. The capability of the magnetic pickup to measure rotational speed of the main shaft from 0 - 5000 RPM was established.
2. A calibration curve for the motor control setting vs the rotational speed of the main shaft was developed to allow an accurate setting of speed even if the magnetic pickup and EPUT meter should fail or give false readings, Figure 7.
3. The speed capability of the shaft assembly rotating in a high vacuum and utilizing commercial bearings was established at rotational speeds of up to 5000 RPM. The level of vibration was considered satisfactory, Figure 8. The diaphragm between the magnets reached a maximum temperature of 180°F due to the rotation of the magnets.
4. A curve correlating the pressure indicated by the ion pump current vs the ionization gauge located in the chamber was developed, Figure 9.

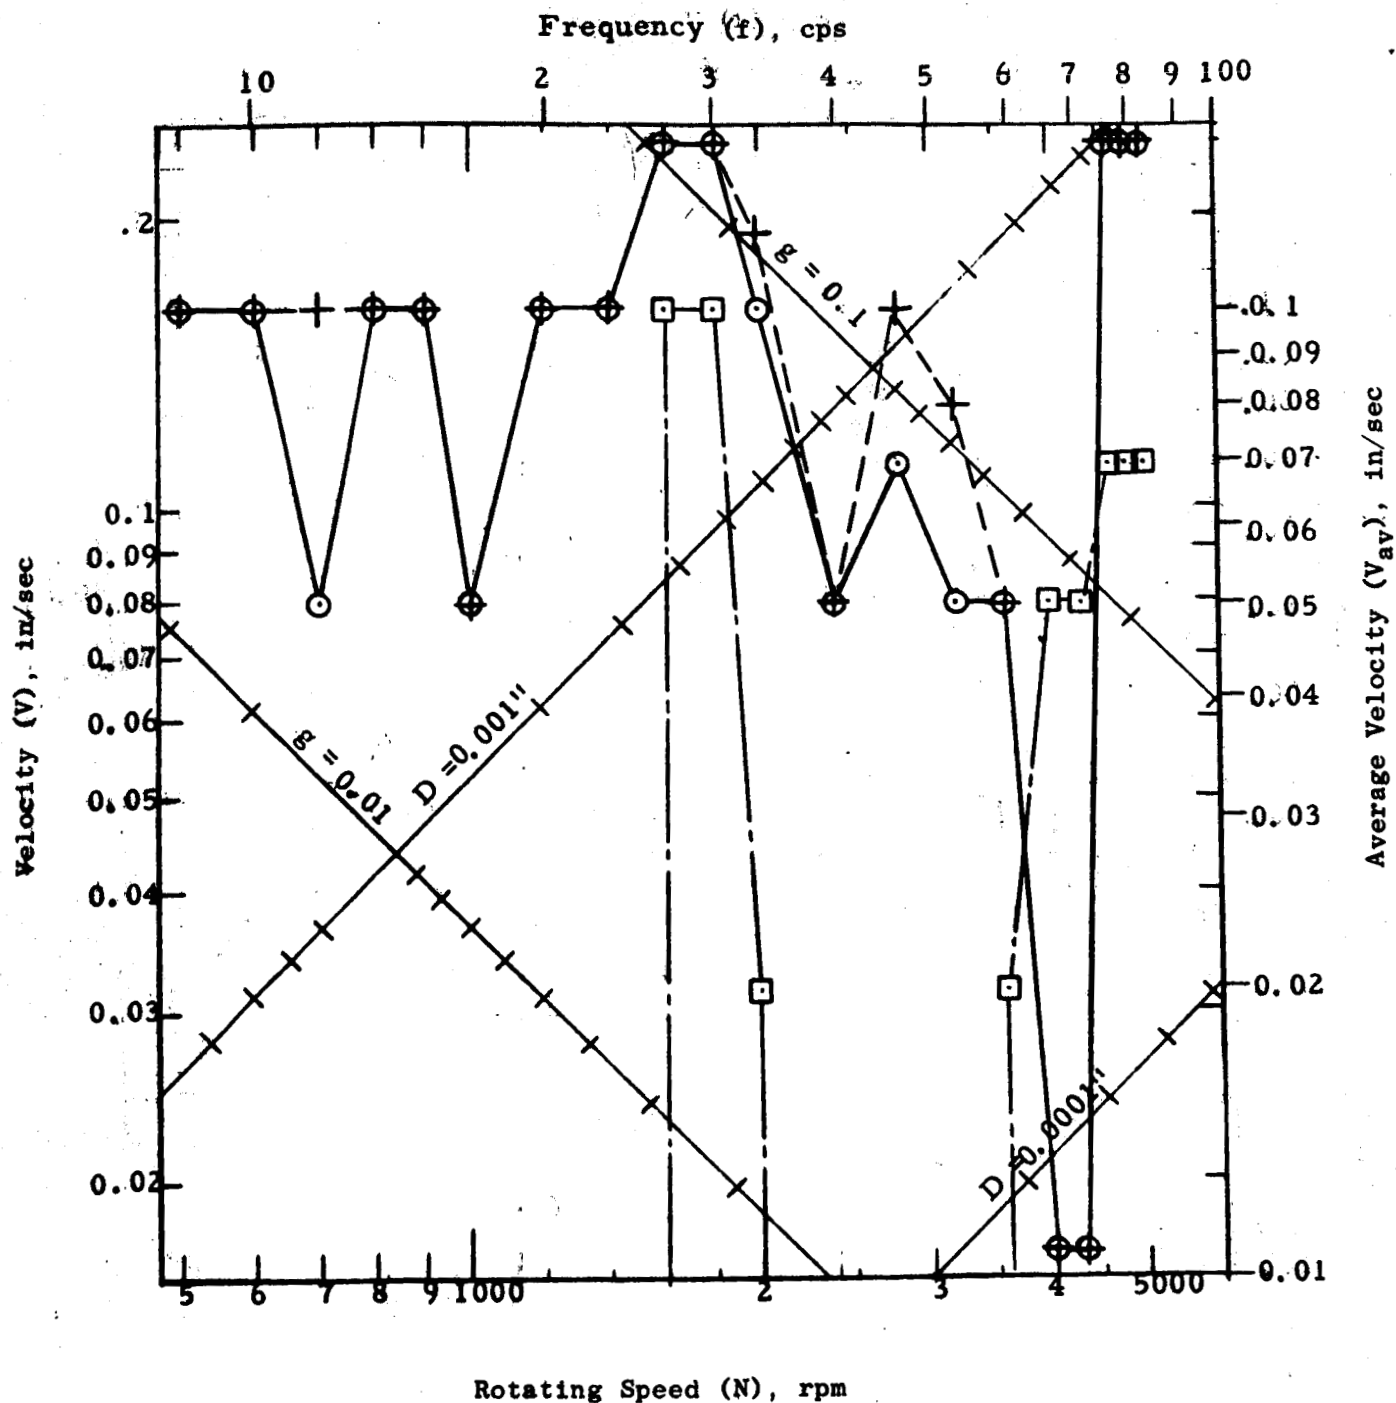
Figure 8. Vibration Performance of High Vacuum Friction and Wear Tester.

D = Peak-to-peak deflection, in.
g = Acceleration, gravity units

○ = Upper bearing, vertical
+ = Upper bearing, horizontal
□ = Lower bearing, vertical & horizontal

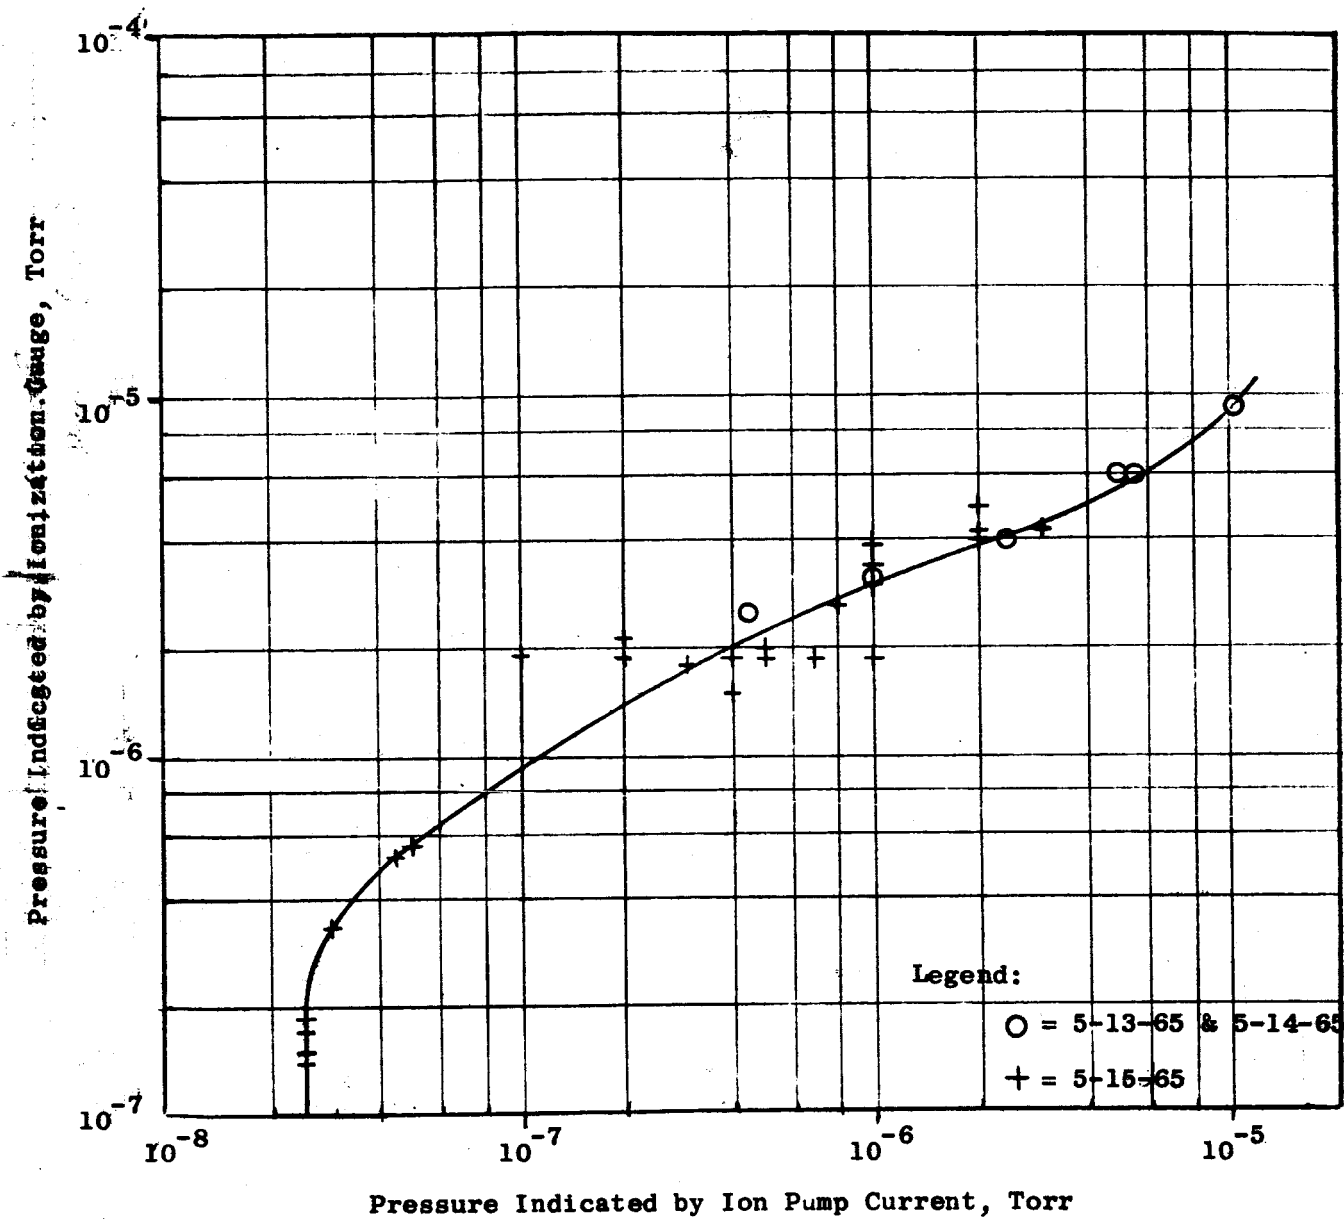
Figure 9. Correlation of Ionization Gauge Pressure with Pressure Indicated by Ion Pump Current.

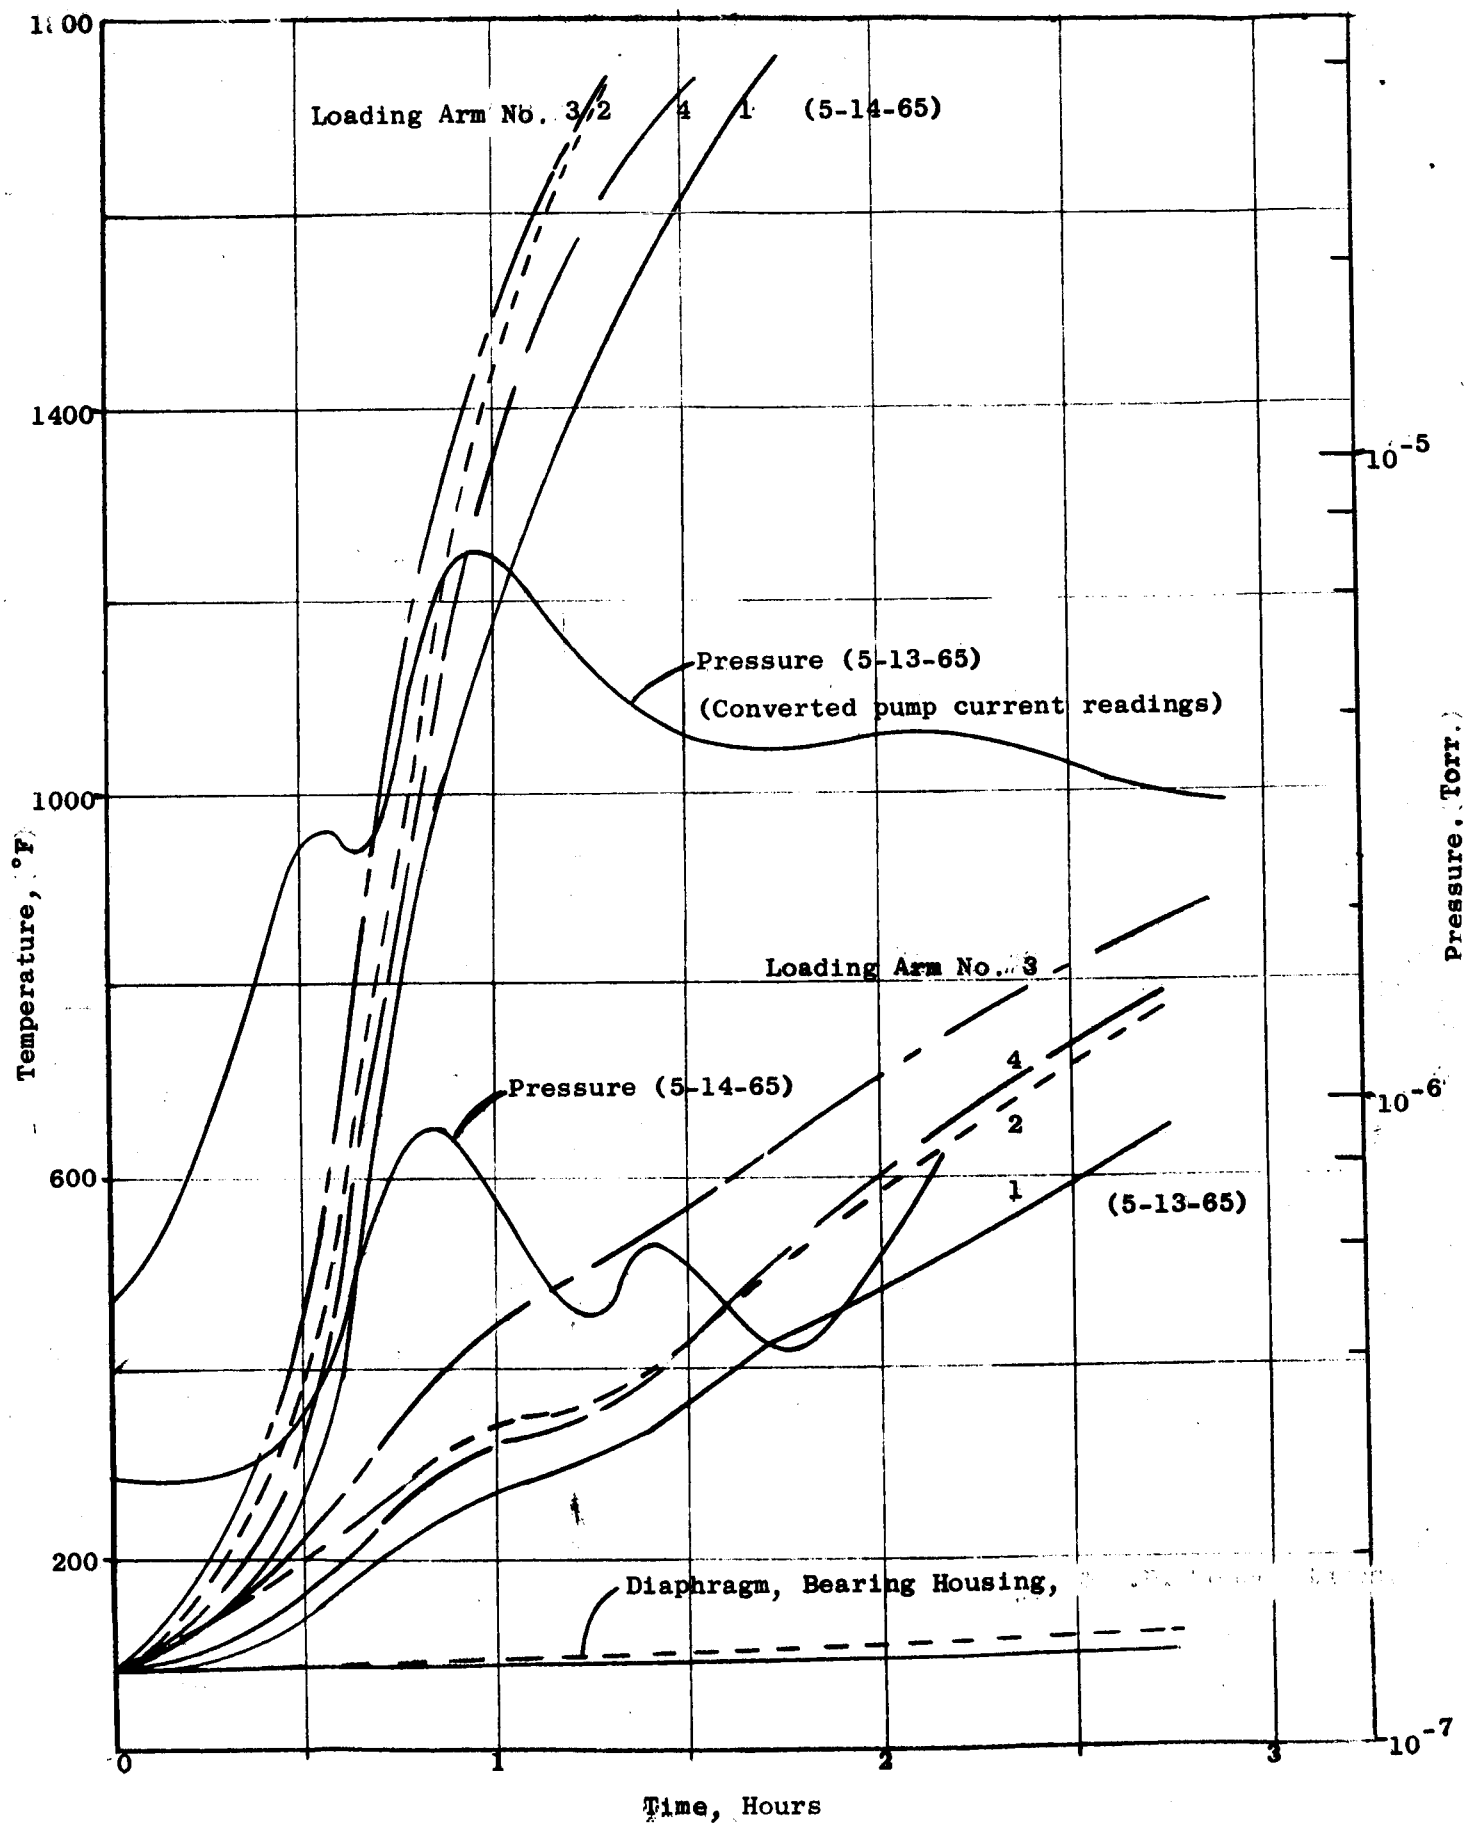
Figure 10. Change in Temperatures and Pressures During Specimen Heater Test.

5. The capability of the specimen heater to heat specimens to 1600°F without exceeding the temperature limits established for the bearings and other critical components of the tester was established; component temperatures remained below 120°F when the rider specimen temperatures reached 1780°F, Figure 10. However, the temperature differential between the rider specimens was greater than desired and as a result will restrict testing to one specimen at a time. This temperature differential is caused by heater geometry, e.g., the presence of the view-port hole.
